Entrapment in Garage Kills One Firefighter

San Francisco, California

75 Everson Street
San Francisco, California

March 9, 1995

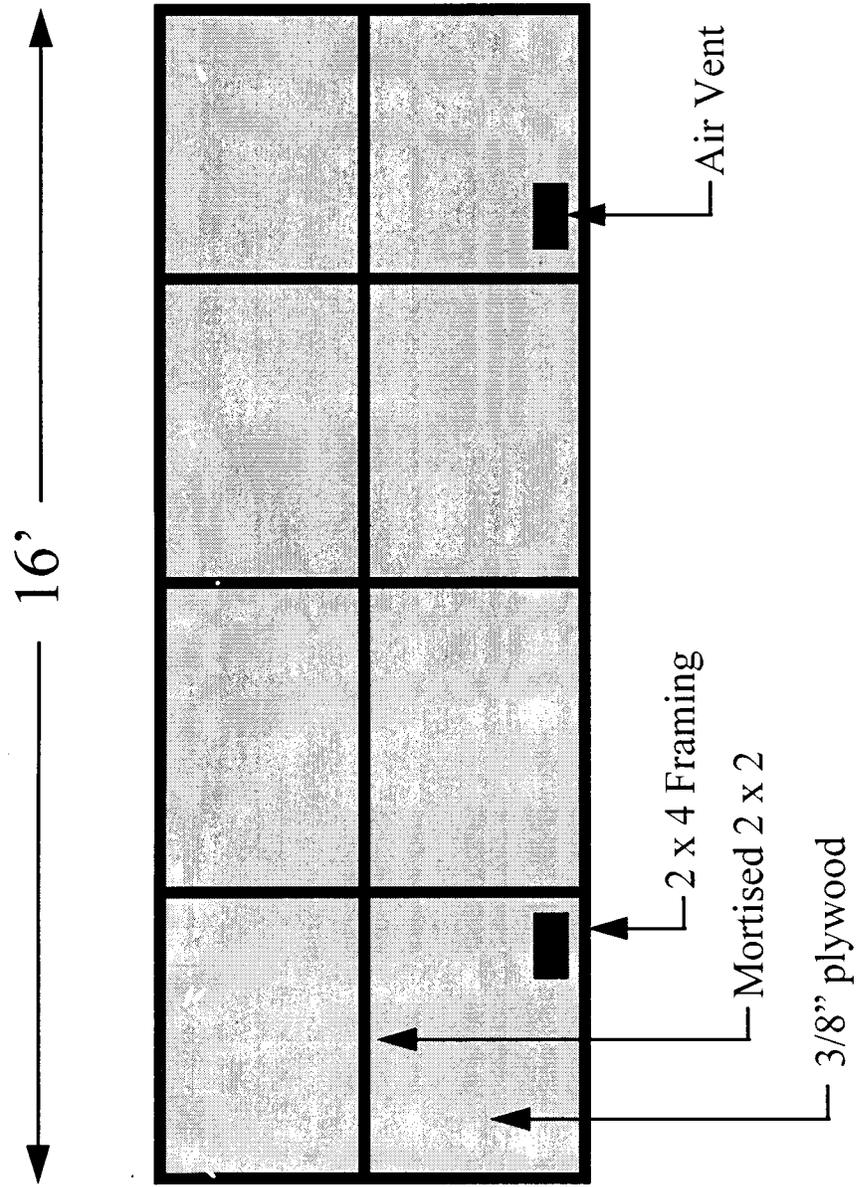
Figure 4

The garage door was a single panel, constructed of 3/8 inch plywood with 2x4 and 2x2 framing (Figure 4). This door was 16 feet wide, 7 feet high and weighed about 250 pounds. Connected to the door was a screw drive type mechanical garage door opener. The opener could be activated by a wall-mounted push button near the door leading to the entry hall (Figure 5) or either of two remote controls. The remotes were kept in the family cars.

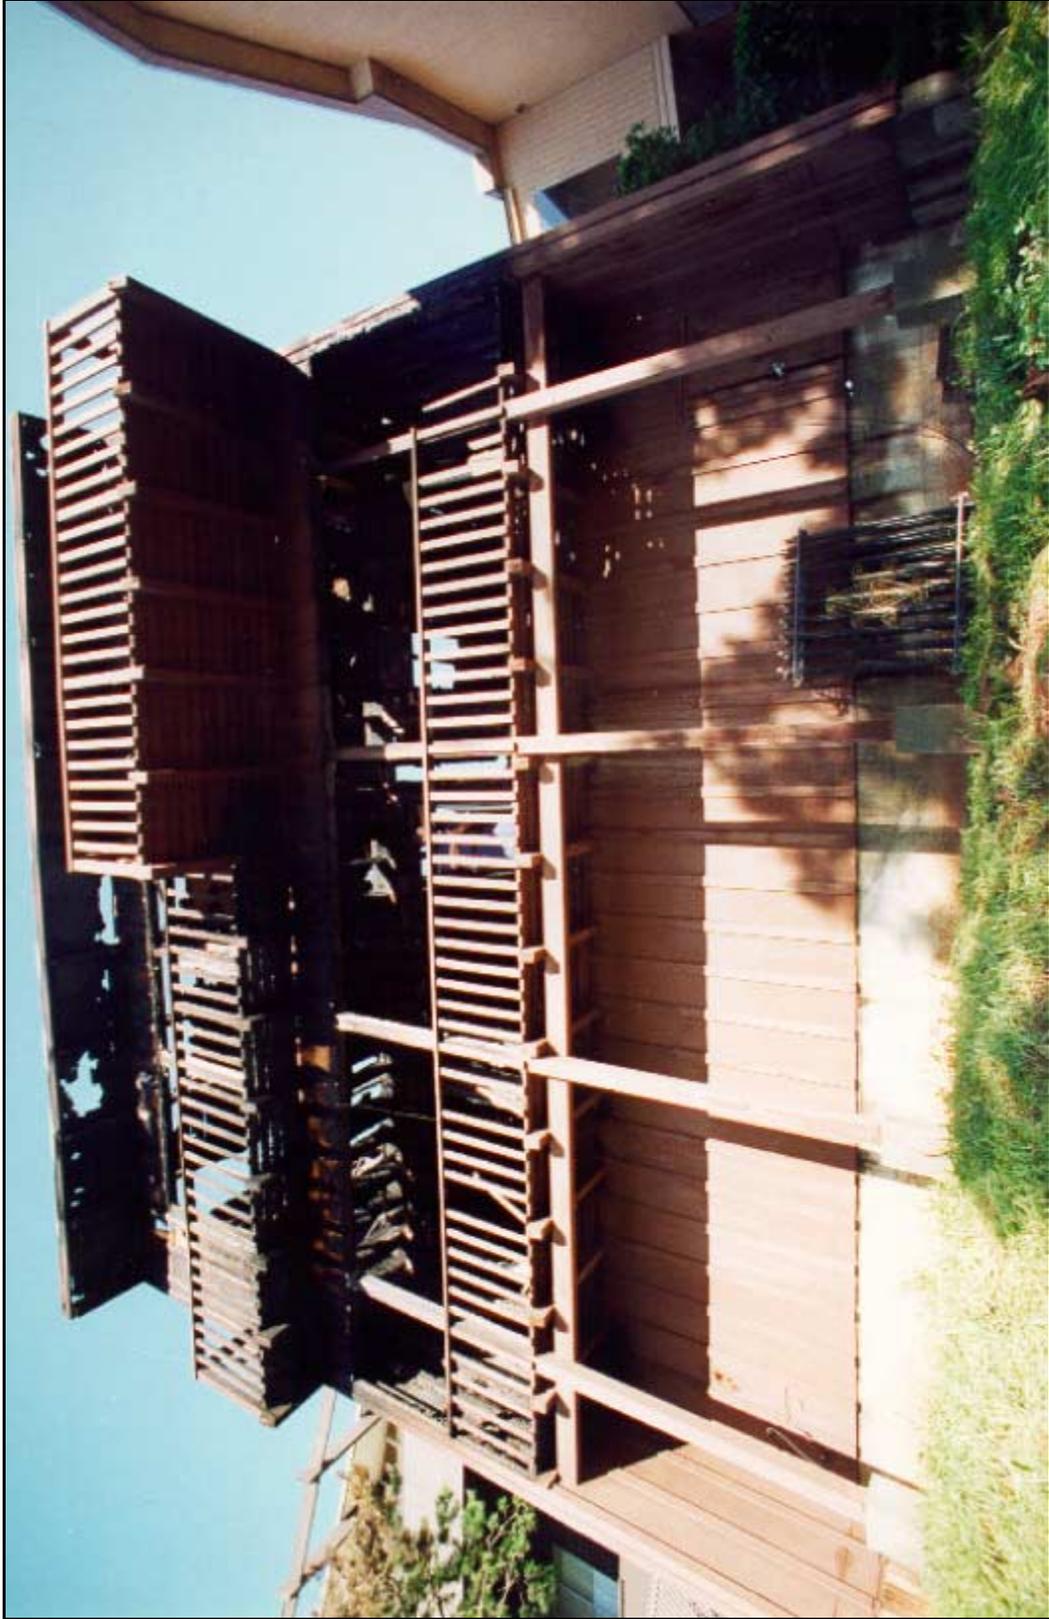
PHOTOGRAPH 2 The rear of the house as viewed from ground level. The fire started in the wall above the lower deck to the right center of the photograph.

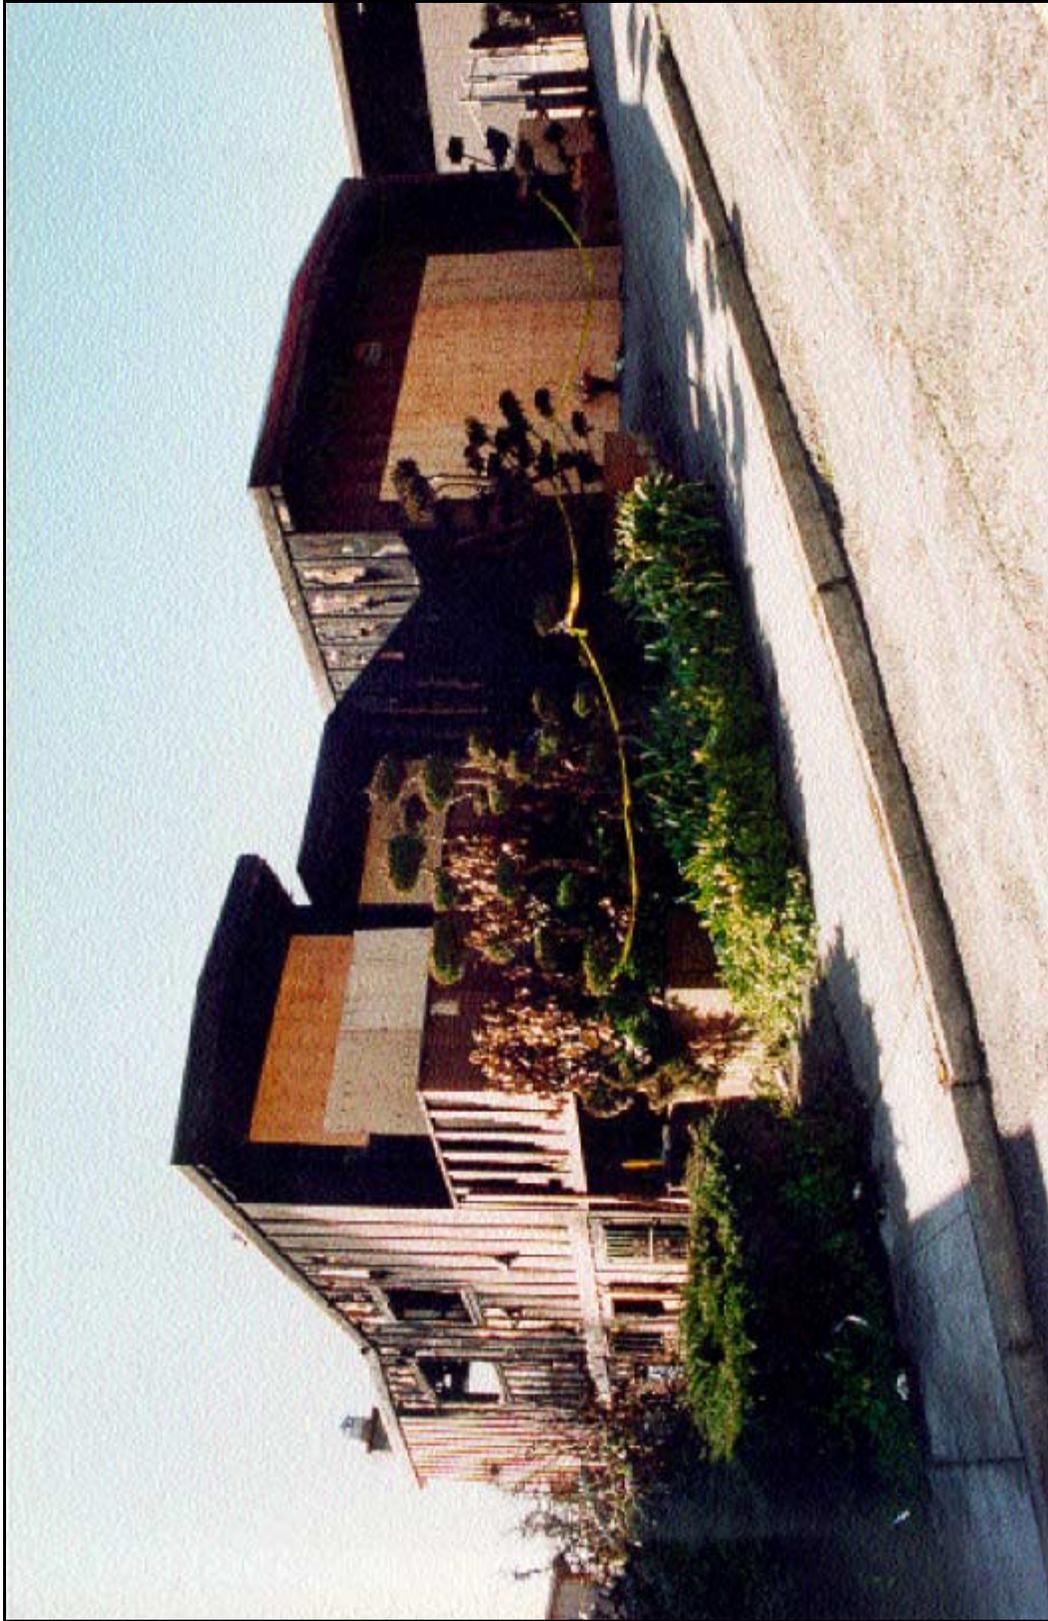
PHOTOGRAPH 3 The northeast corner of the house. Note the security gates on the lower level openings.

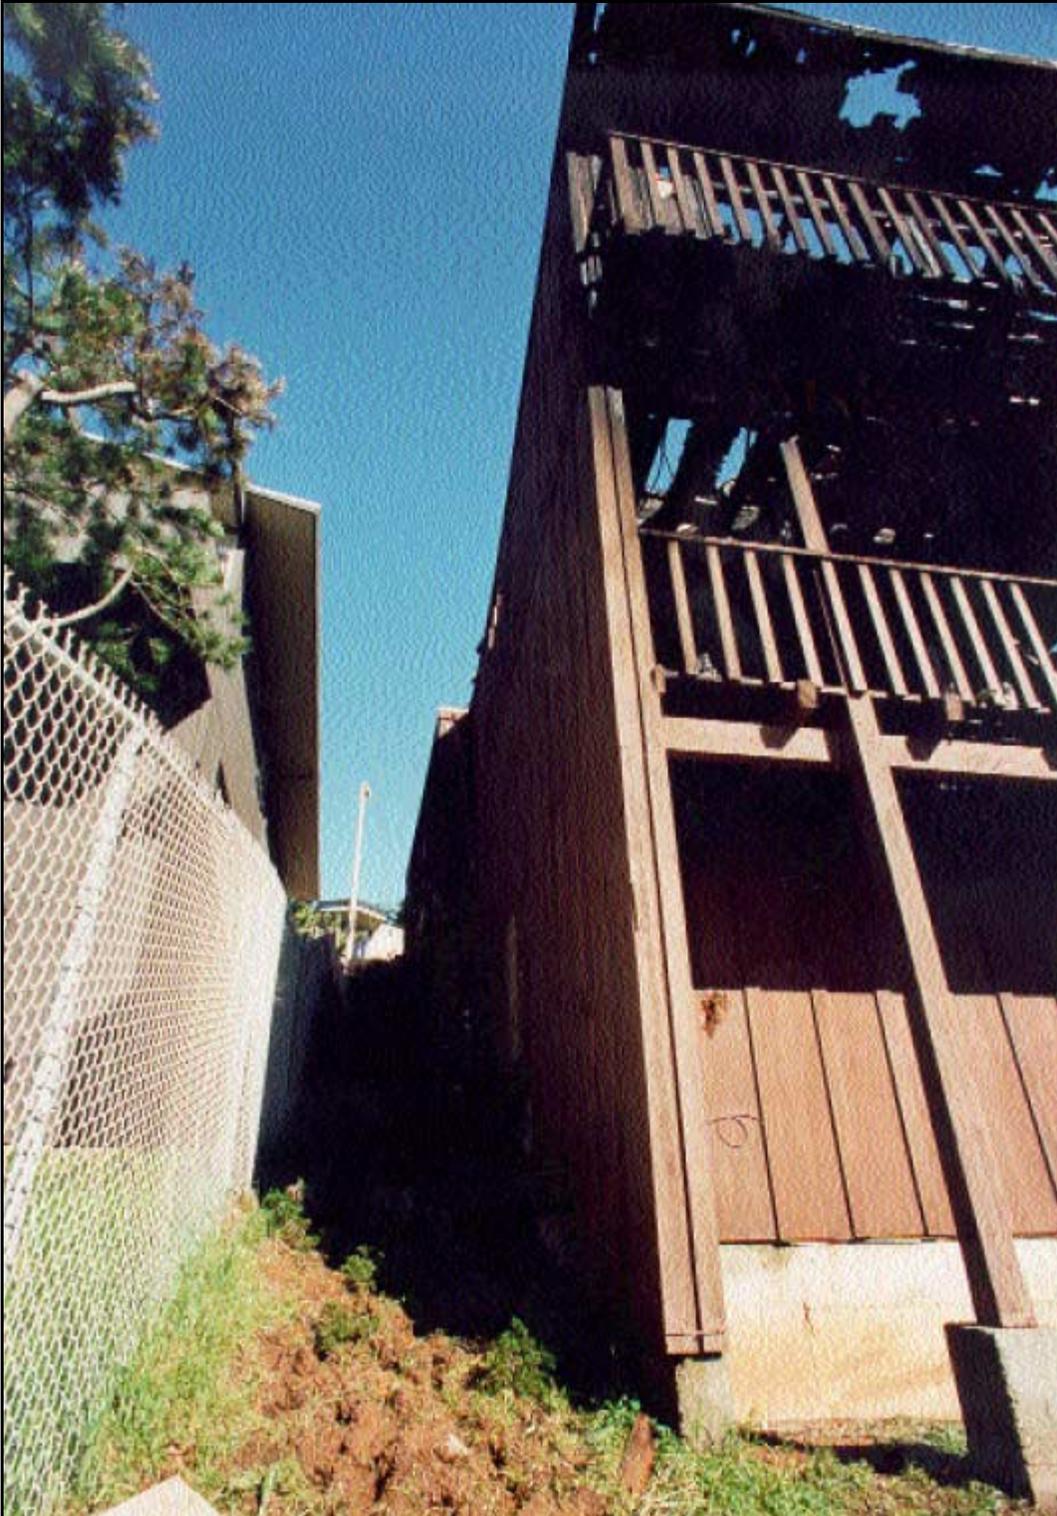
PHOTOGRAPH 4 The southwest corner of the house. Note the steepness of the building lot and the proximity of the house next door.
